# Technical Service Information

## CHRYSLER A518 SERIES NO OR LATE THIRD GEAR

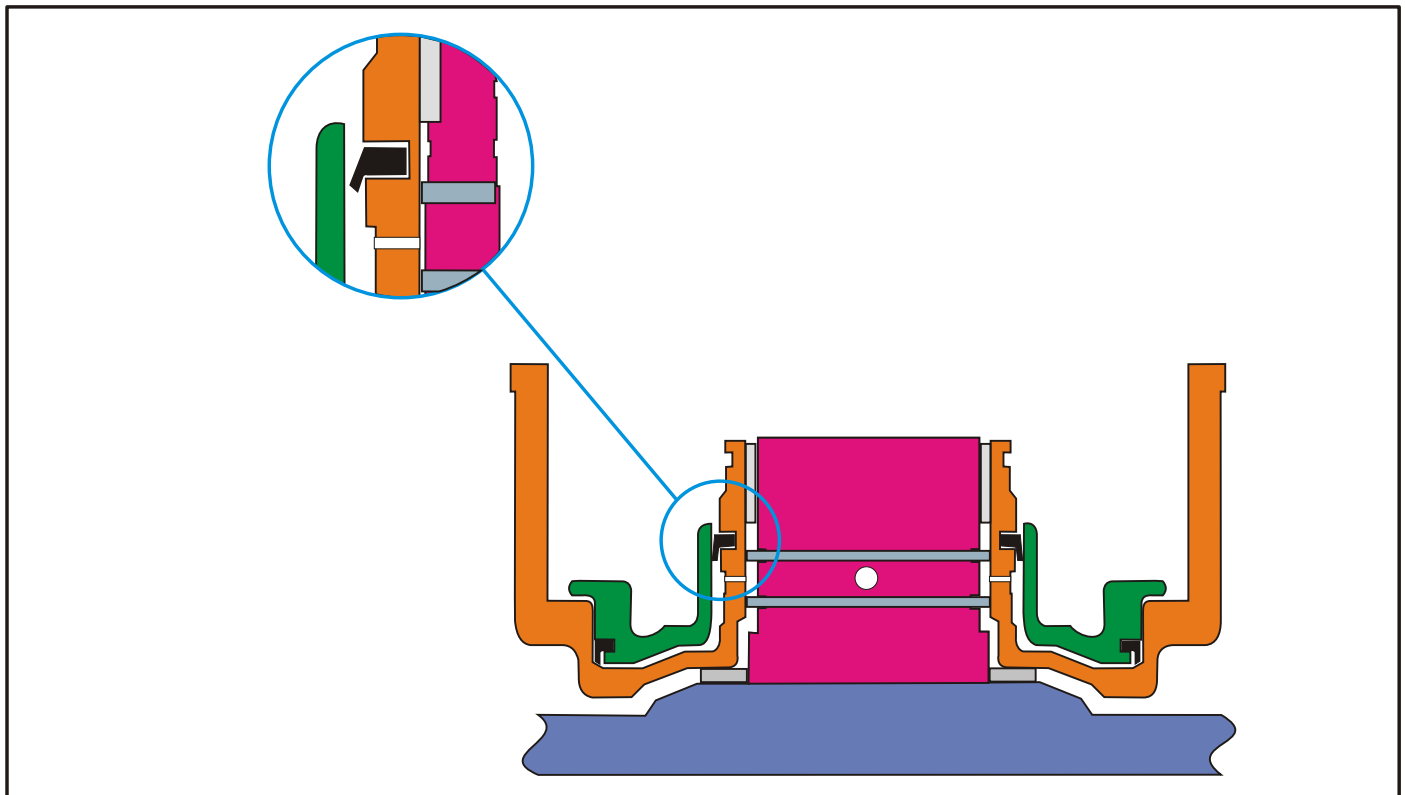
Figure 1

**CAUSE:** Some direct clutch drums had the inner seal groove cut too deep. This allows for the inner seal to be swallowed up into the groove causing poor retention of fluid (See Figure 1). Another possibility is the outer lip seal being worn due to a poor finish of the drum, in the contact area

**CORRECTION:** Replace the inner lip seal with a larger radial base. Aftermarket sources such as TransTec/Freudenberg-NOK and Precision International produce a wider base seal to accommodate the deeper depth of the groove. Also Shift Technology Products packages an inner lip seal in their K500-618 kit. Replace the outer seal after polishing the drum, in the contact area of the outer lip seal.
