# Tuning and Understanding your Toyota Viscous Fan Clutch

Landcruiser or Hilux overheating? Your factory fan clutch is probably under-filled and incorrectly set from factory. Fix this first and you may save a lot of time chasing issues.

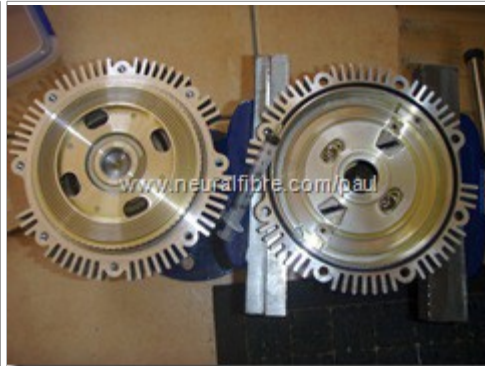
The 2 halves opened

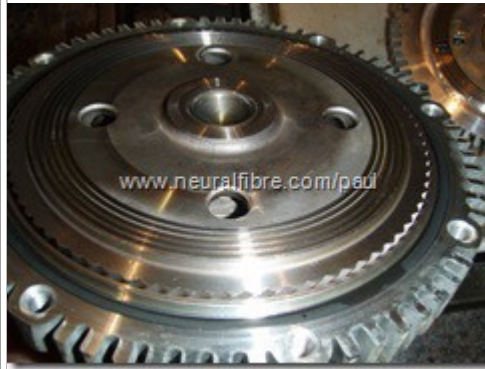
The “drive disc” spins freely in the housing except for the silicon fluid.

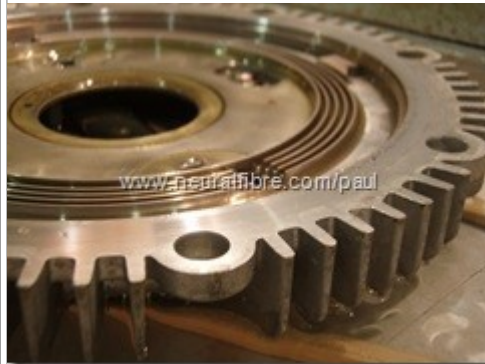
The “drive disc” and the “front half” share these closely spaced rings. It is these rings, and the silicon fluid in the gaps between them that couple the system together. The inner ring is taller than the others.

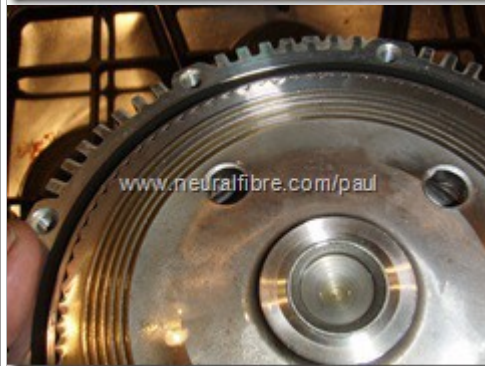
The oil is slowly thrown to the outside of the system by centrifugal force.

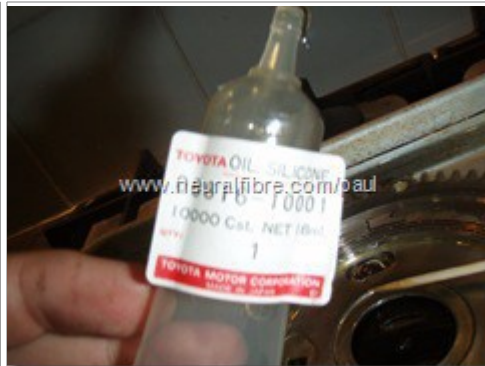
The fluid is rated at 10000 Cst – [Centistokes](#) – a measure of viscosity

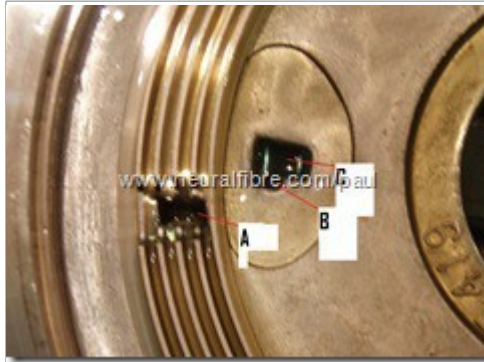
The valve that controls where the fluid flows. It operates over 4 stages:0) Closed

- A) Some oil to some rings
- B) Some oil to all rings
- C) Maximum oil to all of rings

This is why it seems to be more than engaged / disengaged.

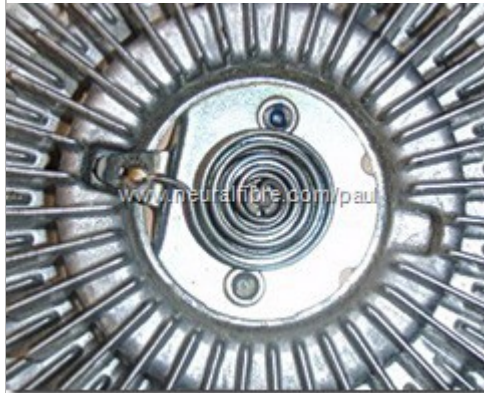
The temperature sensing Bi-Metal spring on the front face that controls the valve.

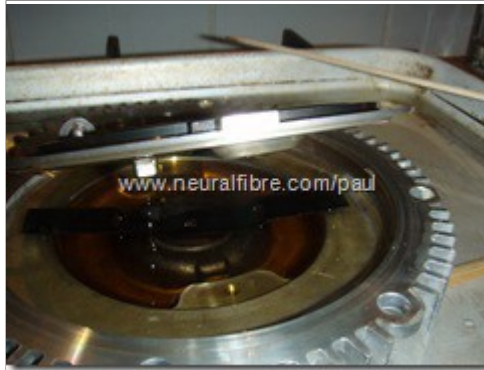
The reservoir behind the valve disc in the front half where the fluid is stored. When operating it is held here by centrifugal force, and pumped here by the slipping “drive disc”

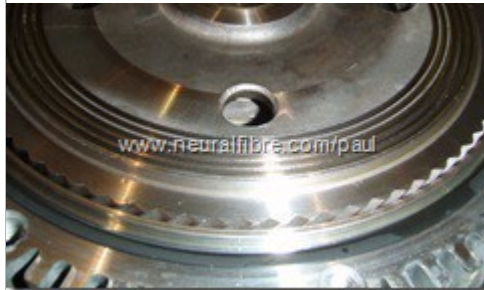
The “vaness” on the edge of the drive disc in the rear half that pump the fluid forward to the outer channel for return to the reservoir. Some slip is required to allow the pumping to occur. The slots in the back of the disc pump the fluid from behind the disc to the edges, and then to the channel at the front.

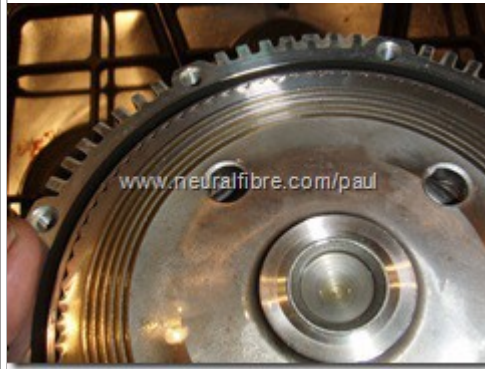
The rear of the disc is not used for coupling.

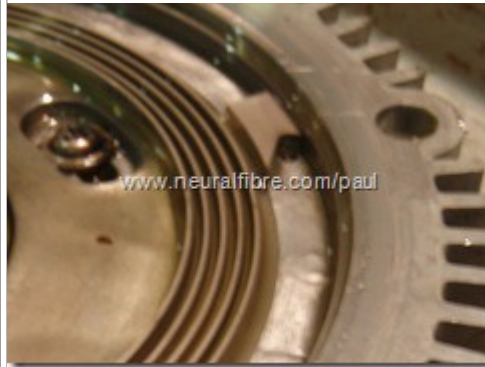
The wedge shaped guides and small holes in the front half that collect the fluid from the outer channel and push it back into the reservoir.

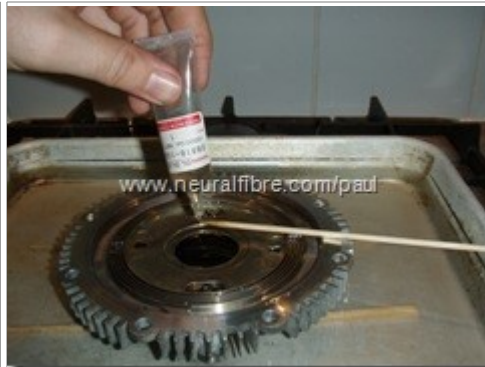
Adding Fluid

This is why so many people report success with simply adding more fluid. Adding fluid means that when the system is operating with the valve fully open, the rings are full of silicon fluid, and not partly full. The only drive is through the fluid, so insufficient fluid will reduce maximum coupling ability. There was clearly not enough fluid in the unit to fill all the rings to the depth of the final valve.

Getting the fluid level right is a little difficult and involves some guesswork. The minimum amount required is enough to fill the entire outer rim past the depth of the fins in both halves, this fully couples the unit.

The maximum amount is when the reservoir in the front is full and overflows through the central hole. Not so simple though, as full is controlled by centrifugal force, so when operating it fills the “outside” of the reservoir, not the bottom.

Luckily there is a fair tolerance between the two. Overfull will couple the fan all the time.

Mine took 1.5 tubes of fluid in addition to the factory fill to stay a few mm below the level of the valve disc.

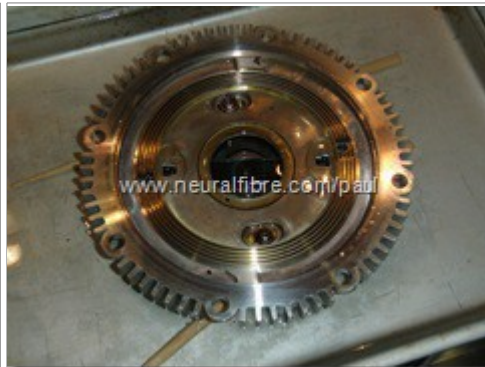
The factory engagement points are also quite high. This reduces noise and fuel consumption, but also means maximum engagement doesn't occur until the air temp is around 95C. Engine coolant temperature will always be higher than air temperature.

Adjust the valve set point by loosening the 2 screws and rotating the disc.  
The outer valve should be 1/2 open at about 45C for Australia. (US quotes 35C).  
Air temp will always be less than engine water temp.
