**THE PROBLEM SOLVER®****PROBLEM:****OE ball joint fails prematurely**

**SOLUTION:****MOOG® Problem Solver®  
Lower Ball Joint K3199/K80767**

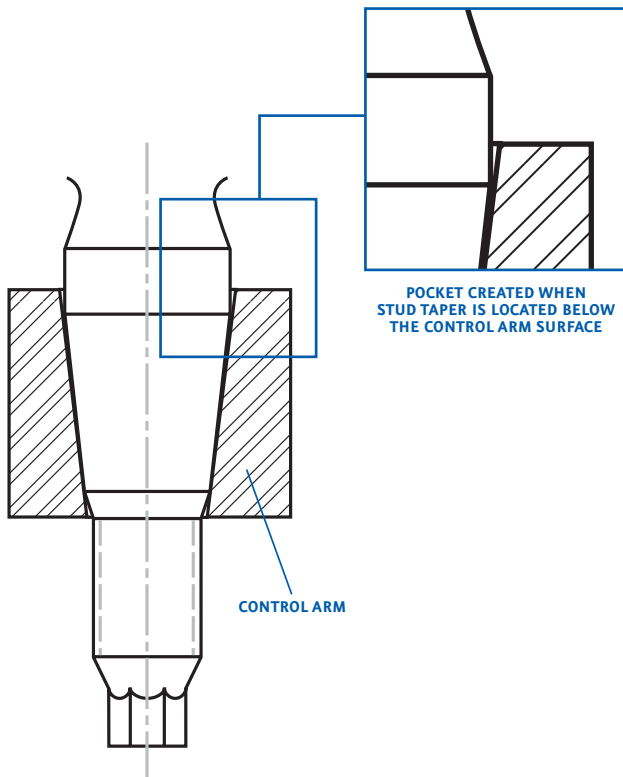
Ball joint boot failures can cause corrosion, accelerated wear and possible joint separation. Failure can be traced to a slight gap between the ball joint stud and control arm. The gap or pocket accumulates moisture, promoting corrosion of the ball joint stud and control arm tapered hole. The corrosion generated by the pocket penetrates under the dust boot, wearing at the sealing surface of the boot. Once exposed to the elements, the sealed, non-serviceable ball joint quickly degrades and fails.
