# Tuning and Understanding your Toyota Viscous Fan Clutch

Landcruiser or Hilux overheating? Your factory fan clutch is probably under-filled and incorrectly set from factory. Fix this first and you may save a lot of time chasing issues.

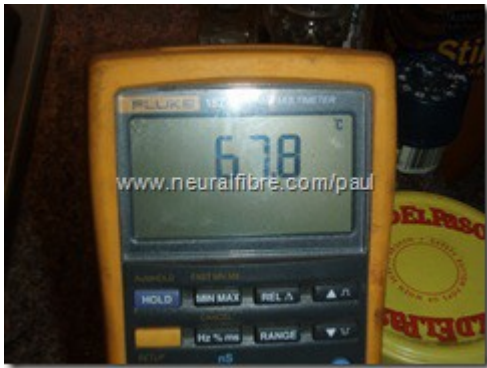
The factory engagement points are also quite high. This reduces noise and fuel consumption, but also means maximum engagement doesn't occur until the air temp is around 95C. Engine coolant temperature will always be higher than air temperature.

This was all tested with a Digital Thermometer and a water bath on the stove. The water was heated and cooled and the valve set points noted as it moved.

### Temperature Set Points (all at 1/2 open)

| Stage | Original Temp | Adjusted Temp |
| Closed | 50 | 40 |
| Stage 1 | 55 | 45 |
| Stage 2 | 85 | 75 |
| Stage 3 | 95 | 85 |

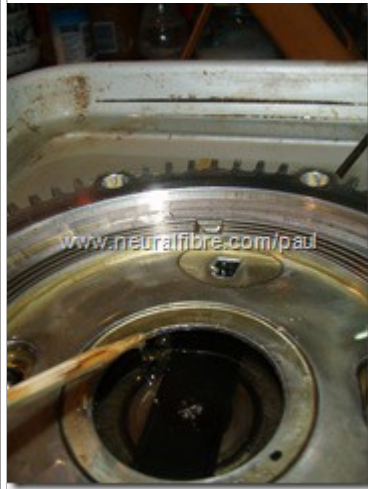
The maximum amount is when the reservoir in the front is full and overflows through the central hole. Not so simple though, as full is controlled by centrifugal force, so when operating it fills the “outside” of the reservoir, not the bottom.

Luckily there is a fair tolerance between the two. Overfull will couple the fan all the time.

Mine took 1.5 tubes of fluid in addition to the factory fill to stay a few mm below the level of the valve disc.
